February 9, 2017

RE: Notice of Determination for Mater Dolorosa Church Building

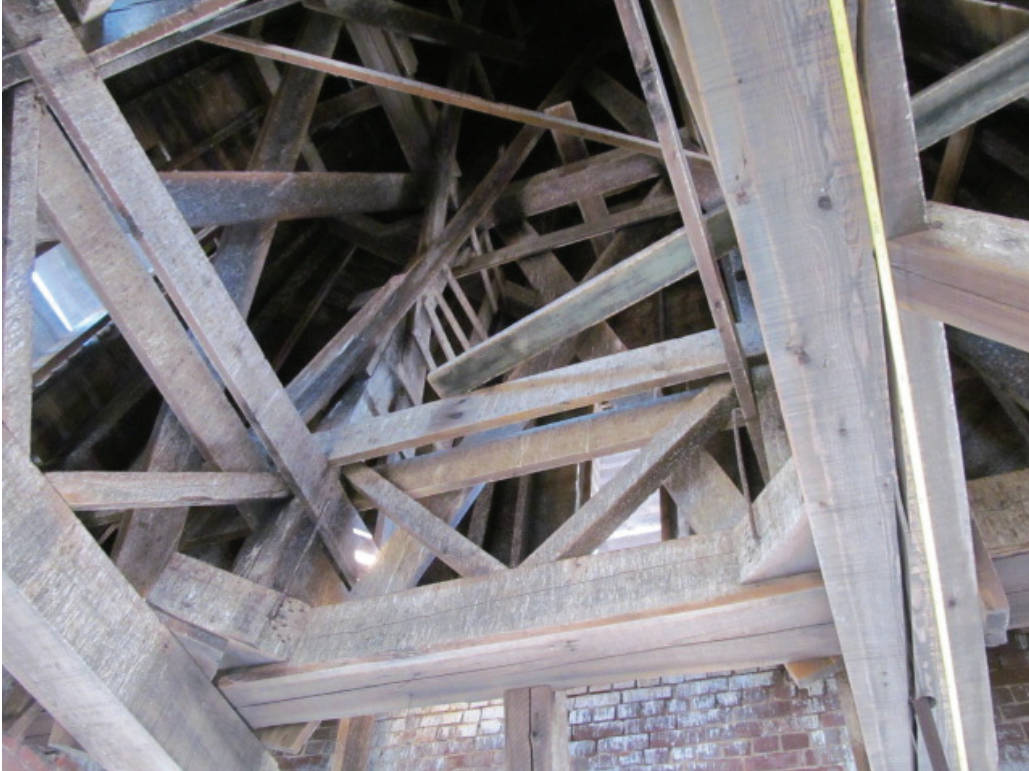
Main wood structural support beam with significant crack through the entire length and depth. Steel tension rods which pass through the wood beam are loose. This condition is not due to the lack of routine maintenance.

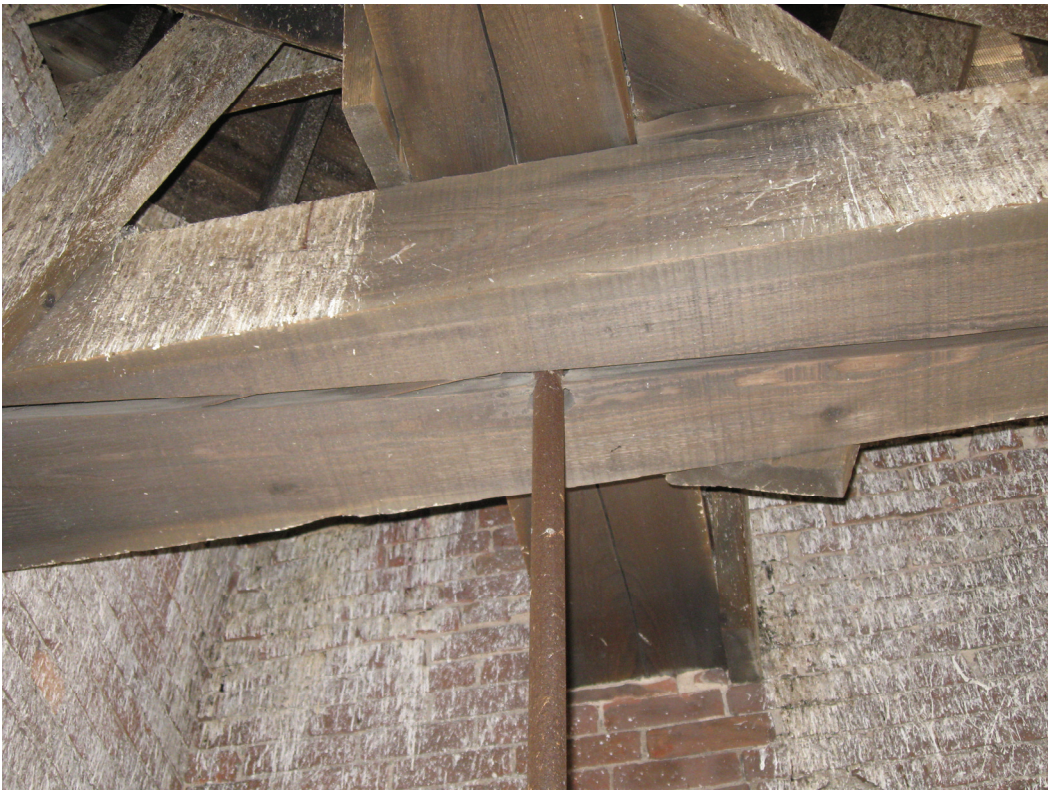
Wood structural support beam with significant cracks the length and depth of both beams. Structural steel tension rods which provide stability and support are loose and not effective. Wood beams are pocketed into brick wall with loose brick and mortar

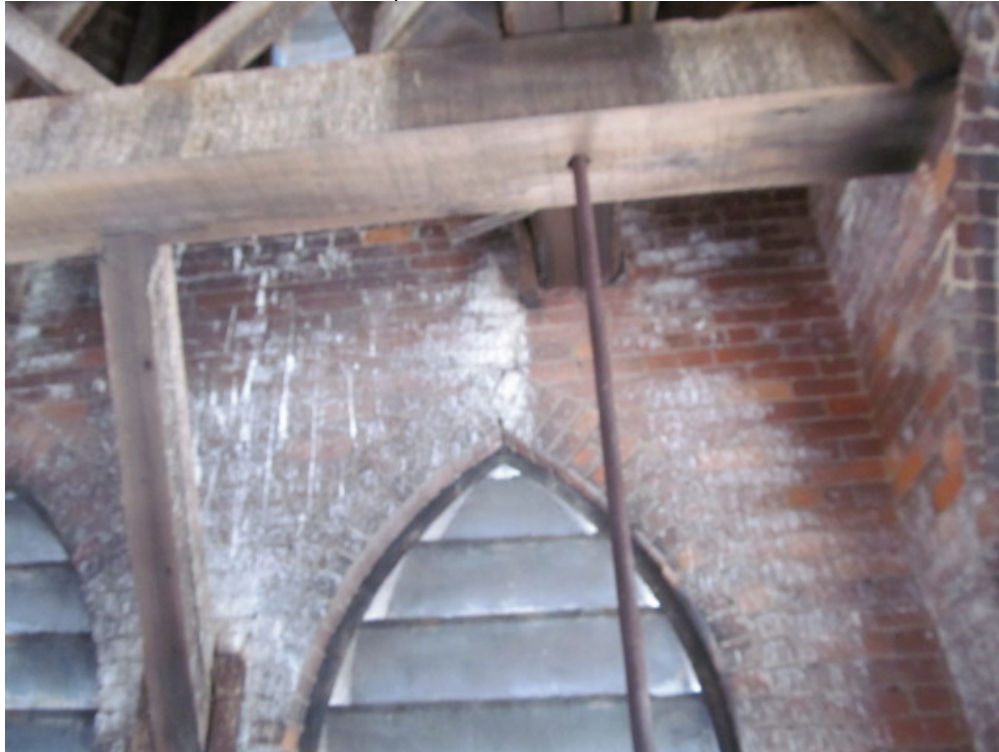
Main wood structural support beam with steel tension rod. Structural wood beams are pocketed into the brick structure.

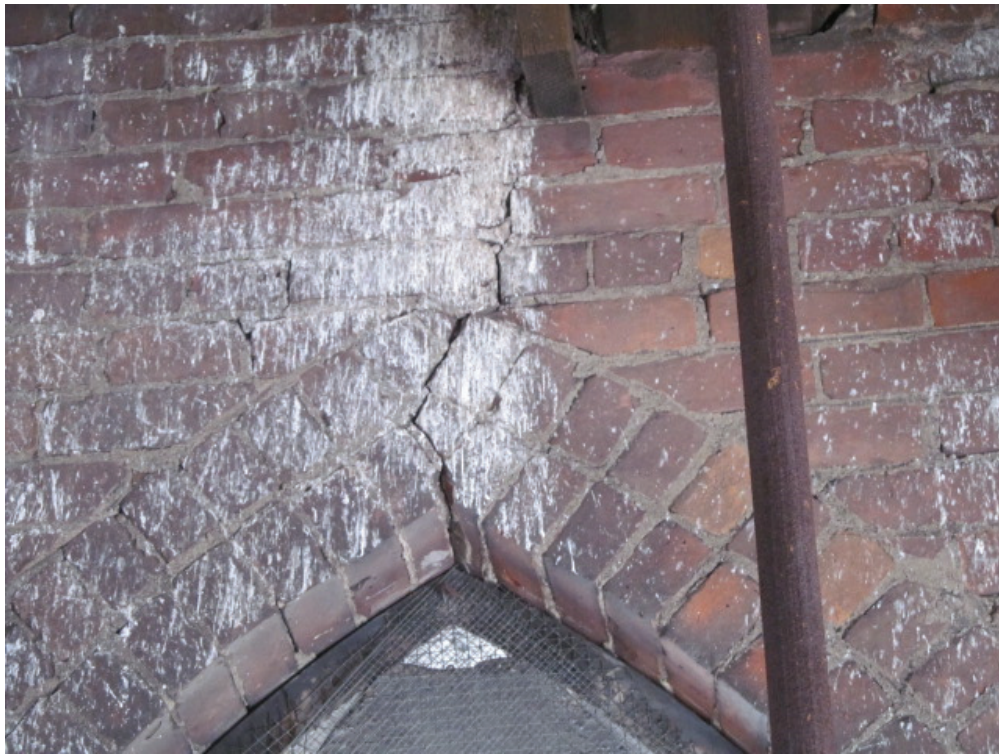
Close up photo of brick structure showing crack through the entire thickness of wall. It is important to note the small section of brick at the top of the opening and the location where the main structural wood beam is pocketed into the brick. This condition is not due to the lack of routine maintenance and simply repointing of brick would not be an acceptable repair option. This condition would require rebuilding of exterior brick walls.

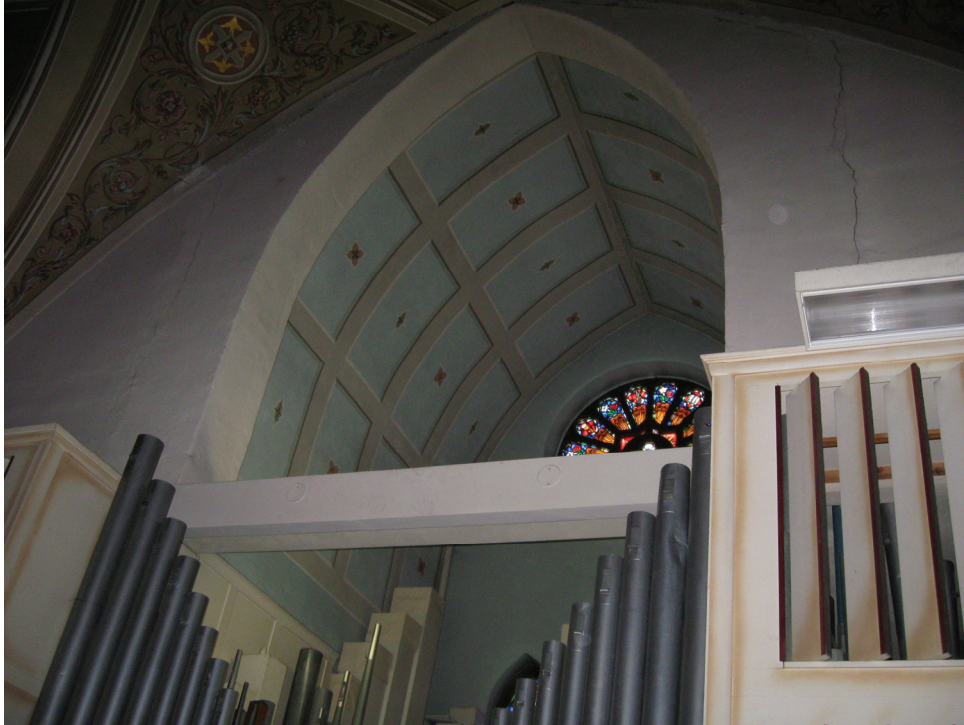
Significant cracks in plaster on both sides and ceiling of choir area. Plaster cracks are representative of the brick steeple located directly behind this wall. These cracks reported by parishioners in 2011 and are what prompted the initial structural assessment of the steeple.

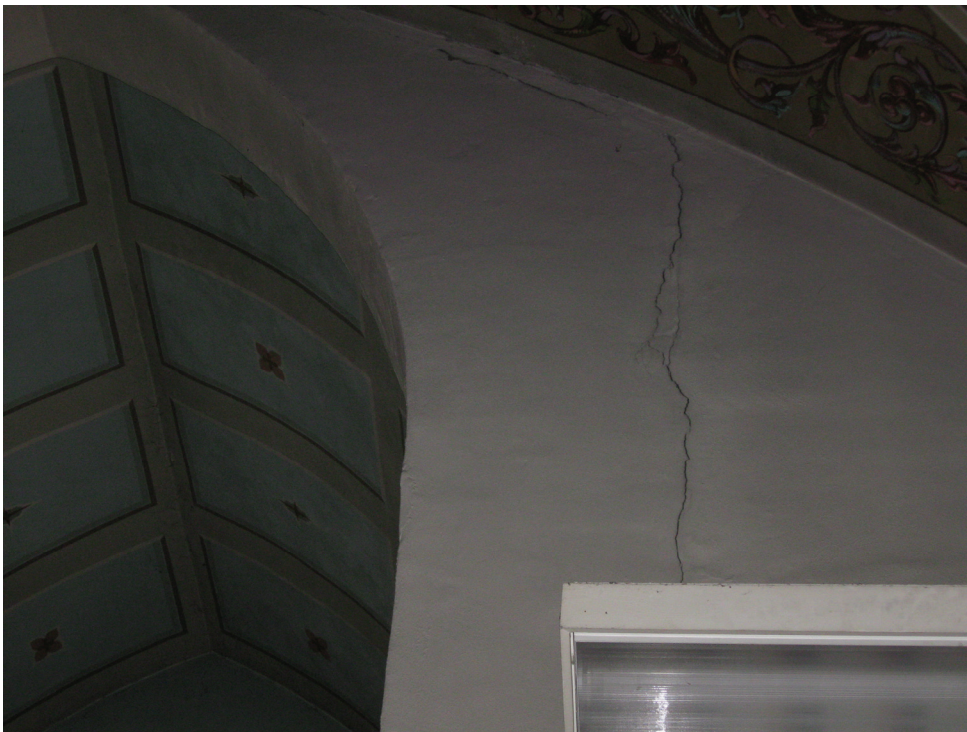
Close up photo of plaster crack in choir loft. It is important to note these cracks appeared suddenly and prompted a structural assessment which identified dangerous conditions. This condition documents movement of the church steeple and is consistent with the structural engineering findings of major cracks in structural wood beams, loose steel tension rods and structural damage to the brick exterior walls. It should also be noted this was a sudden event and not due to lack of maintenance.
